Information on Glass Products

This service bulletin should be used as a guide to evaluate glass products for potential replacement. Subject matter addressed includes:

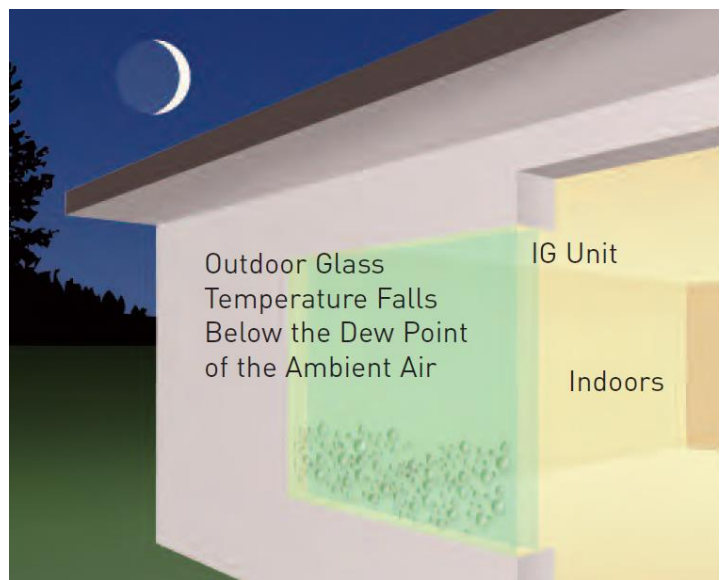
Outdoor Condensation

Glass units should not be replaced for complaints or concerns when outdoor condensation occurs. Condensation on the outdoor glass surface of an insulating unit is not an indication that the glass or insulating unit is defective. Under the right set of atmospheric conditions it is possible to get condensation on the outdoor surface of an insulating glass unit. Specifically, these conditions are as follows:

Exposed to the above conditions, the outdoor glass surface can radiate heat away to the night sky, and with good insulating glass products the outdoor glass temperature can fall below the dew point of the ambient air. When this occurs, moisture from the air can condense on the outdoor glass surface. Similarities of this condensation on glass products can be drawn to moisture or dew on lawns or on automobiles when exposed to the above mentioned natural occurring phenomena.
